FLOOD INVESTIGATION REPORT

Investigation Ref:	50
Location:	Cossington, Main Street
Date of Flooding:	1 st October 2019

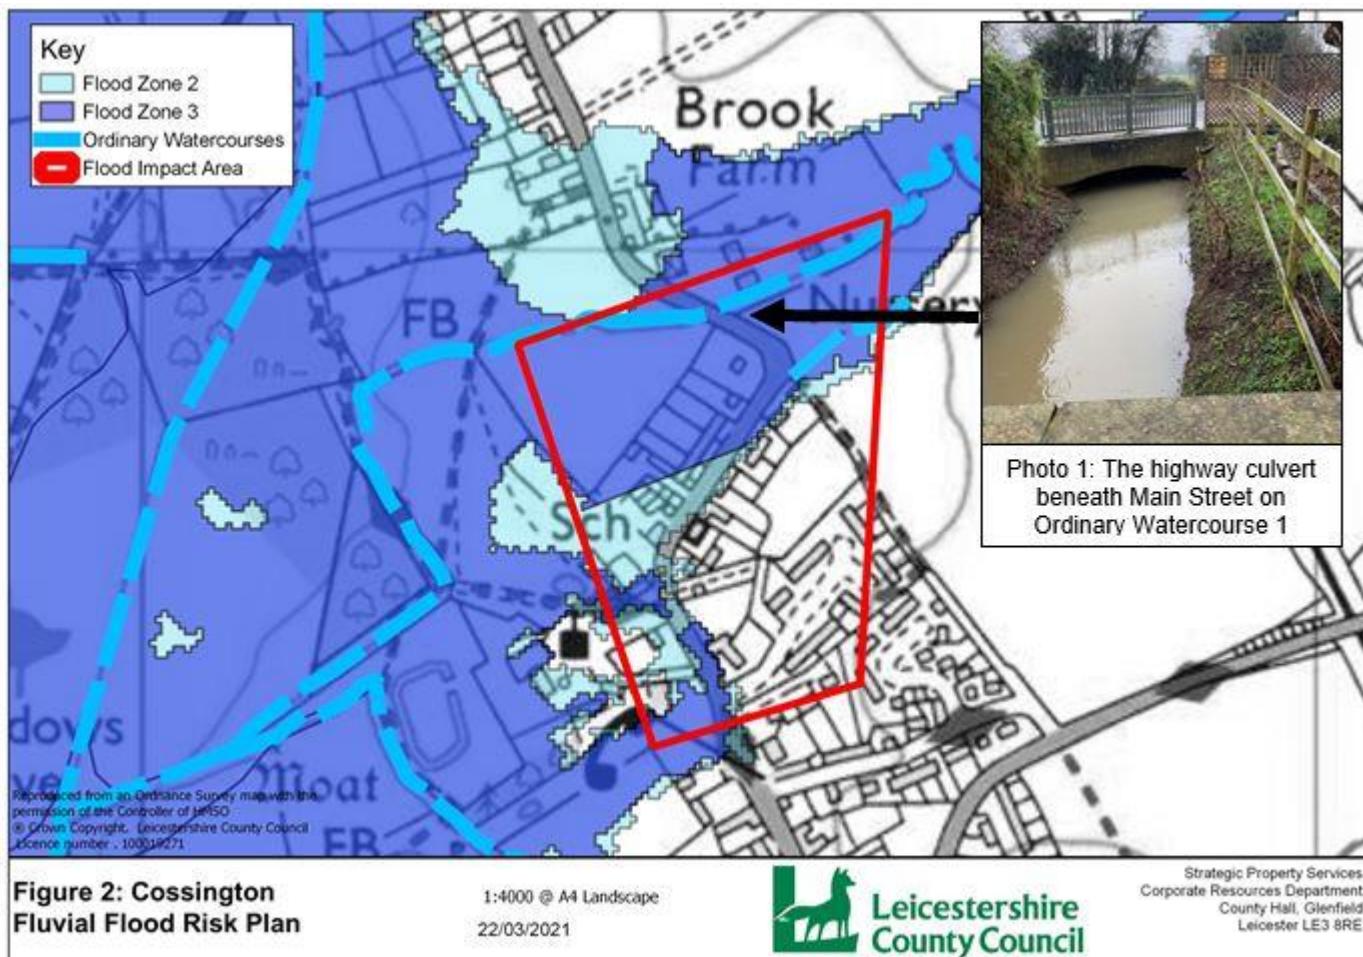
Cossington village is in Charnwood Borough (Figure 1) in the River Soar sub-catchment of the Humber River Basin District. The residential properties impacted during the 1st October 2019 flooding event are located to the north of Main Street, which is the main highway that runs through the centre of Cossington, south of where Ordinary Watercourse 1 is culverted beneath Main Street (Figure 1).

Ordinary Watercourse 2 was found during a site visit following the flood event and was not initially displayed on any mapping available to the Council (Figure 1). Information regarding its source and connection with the ordinary watercourse network is therefore limited.
