Flood Investigation Report

Stoney Stanton – 1st October 2019

Final Report

April 2021

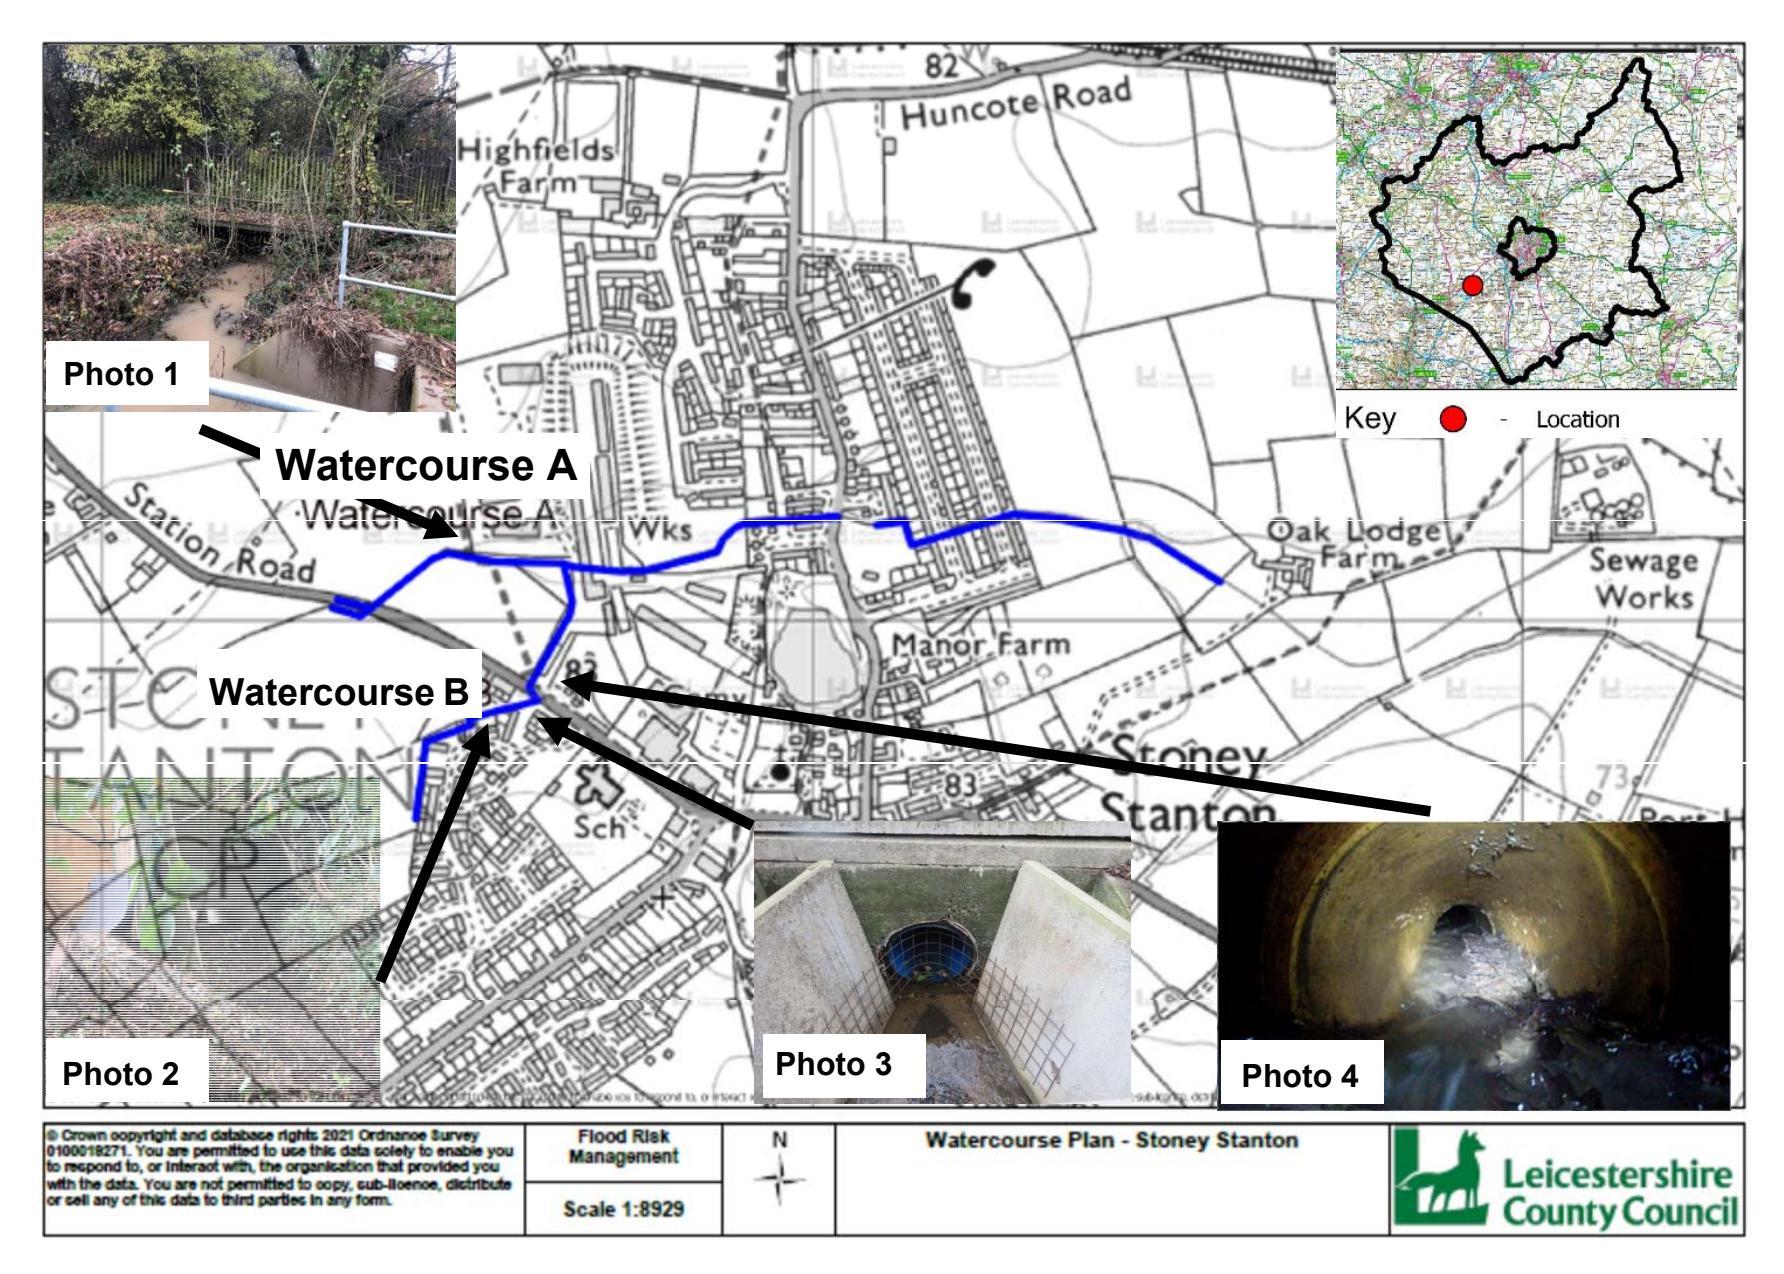
Figure 1: Location of Stoney Stanton and key watercourses

To the west of the village, a large area of agricultural land drains in a north easterly direction towards the B581 (Station Road) via a network of ditches (ordinary watercourses, highlighted in Figure 1). The watercourse (identified as watercourse A) flows beneath Station Road in a 1050mm highway culvert, and then to the north of the Godfrey Close development in a vegetated open channel. Notable features in this section of watercourse A include a surface water outfall headwall and a footbridge with adjacent fencing within the watercourse (depicted in Photo 1 and located approximately 100m upstream of the Foxbank Industrial Estate). Watercourse A remains an open channel before being culverted through the Foxbank Industrial Estate in a 900mm diameter culvert (an informal trash screen exists at this inlet). There is then a small transect of open watercourse in a section of undeveloped land upstream of Meadow Close (owned by Jelson Homes). The culvert inlet to the rear of Meadow Close is covered by a trash screen before flowing in a dual 750mm culvert, maintained by STW. A short (approx. 90 metres) section of open watercourse, adjacent to Long Street, conveys flow from the dual 750mm culvert to a privately owned 1200mm culvert running under multiple residential properties. The watercourse then discharges into an open watercourse in agricultural land to the east of Stoney Stanton flowing east towards the River Soar.

Watercourse B exists in an open channel upstream of the chamber where it joins with the 600mm culvert/pipe from Robertson Close. It remains open channel for approximately 60m before being culverted in a 300mm pipe (covered by a private trash screen as shown in Figure 1) under a single private garden. It is then open again for a small section and enters another 300mm culvert where there is another informal trash screen (Figure 1).

Watercourse B leaves private land towards Station Road in a dual 225mm diameter culvert, it then becomes a 670mm diameter culvert beneath Station Road before reducing down to a 300mm diameter culvert (Figure 1). A high-level overflow (450mm diameter) is present from one of the chambers beneath Station Road outfalling into a cut-off ditch adjacent to Foxbank Road.

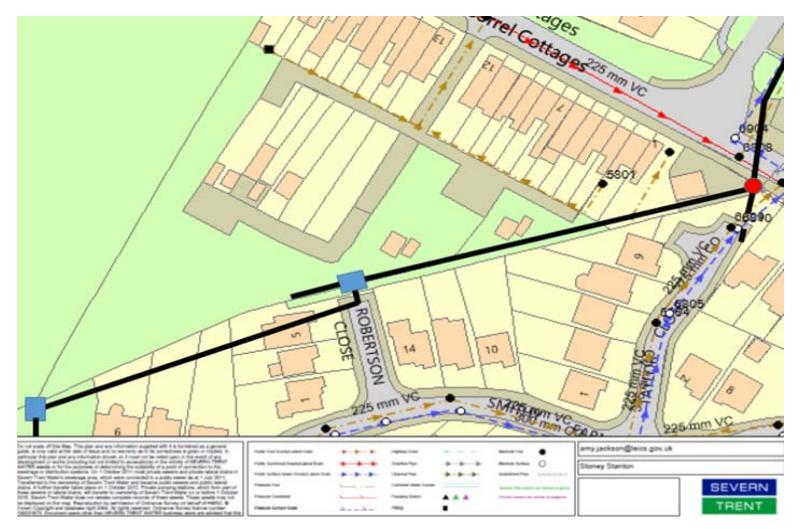
Figure 2: Connectivity of the surface water drainage system serving the agricultural land drainage system to the west of Mountsorrel into watercourse B. STW Plan with annotation provided by Stoney Stanton Flood Action Group

The extent of the catchment of watercourse B has not yet been understood in its entirety, however following a site walkover and based on evidence obtained locally, a large area of agricultural land to the west of the village drains into the watercourse. The field drainage in this location enters a chamber (adjacent to Fisher Close) before being conveyed in a 600mm culvert/pipe (beneath the land of four residential dwellings) towards Robertson Close. This culvert/pipe then takes a sharp bend beneath Robertson Close towards Mountsorrel Cottages, before discharging perpendicular to watercourse B in another chamber (refer to Figure 2).

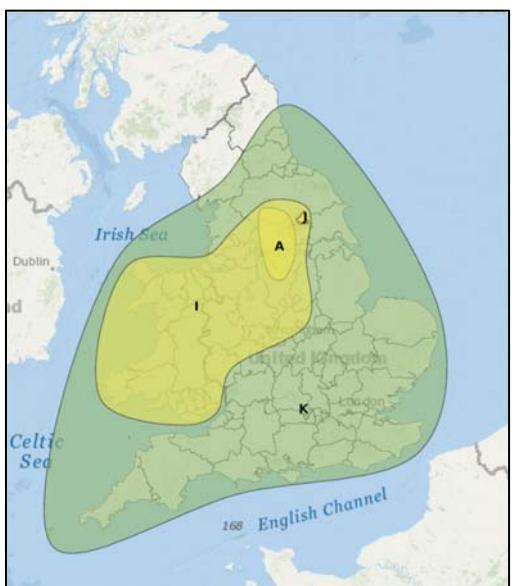
Figure 4: Stoney Stanton fell into an area (marked I) warned by the Met Office that there was a Medium Likelihood of flooding from fluvial and surface water sources of a Minor impact

In the days prior to the flood incident of 1st October 2019, weather warnings had been issued by the Environment Agency covering multiple catchments within central England, including Leicestershire. On the day of the incident, catchments located within central England had already been subject to prolonged and in some cases intense rainfall onto already saturated catchments. On 28th September 2019 the Met Office issued a weather warning covering much of central England (Figure 4) with the area marked below indicated as being at risk of flooding from fluvial and surface water sources, with an estimated duration of up to two days. At this time the Council was on standby for flooding, however it was unknown exactly where and at what time these storms were to hit.

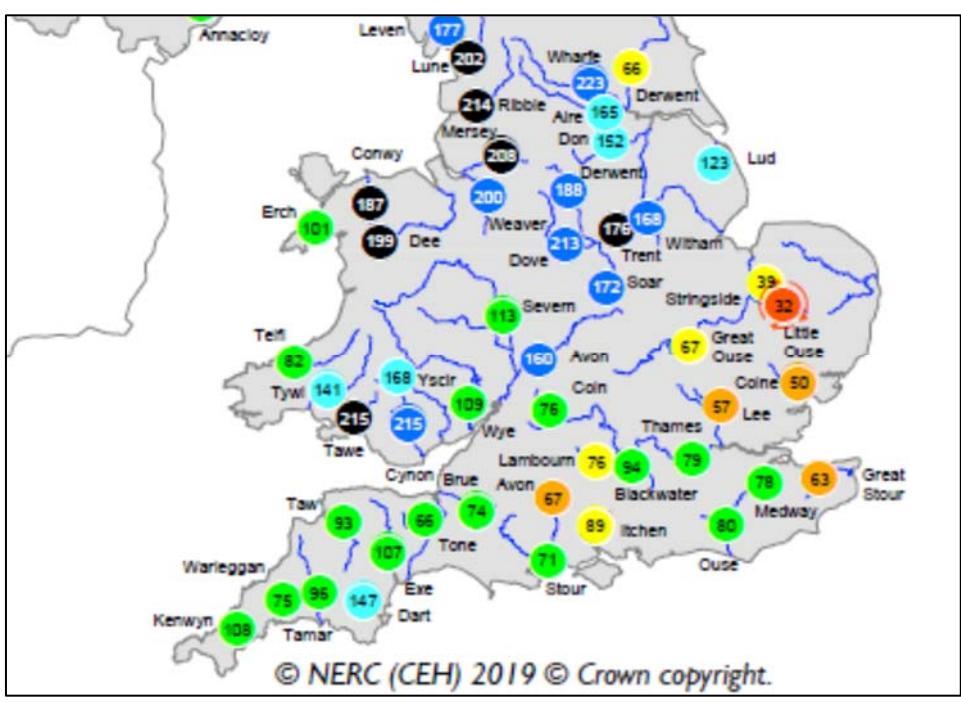
Figure 6: NERC fluvial flow data for August & September 2019. Values (circles) state monthly river flow as a percentage of long-term monthly average.

River flow data collected by NERC during September 2019 in Main River catchments across the UK, illustrated in Figure 6, shows that fluvial flows within the area were approximately 172% of the long-term average. This highlights the extent to which the catchment and fluvial system were at capacity, with minimal infiltration capacity within catchments, exacerbating surface water flow routes within the catchment during the event.

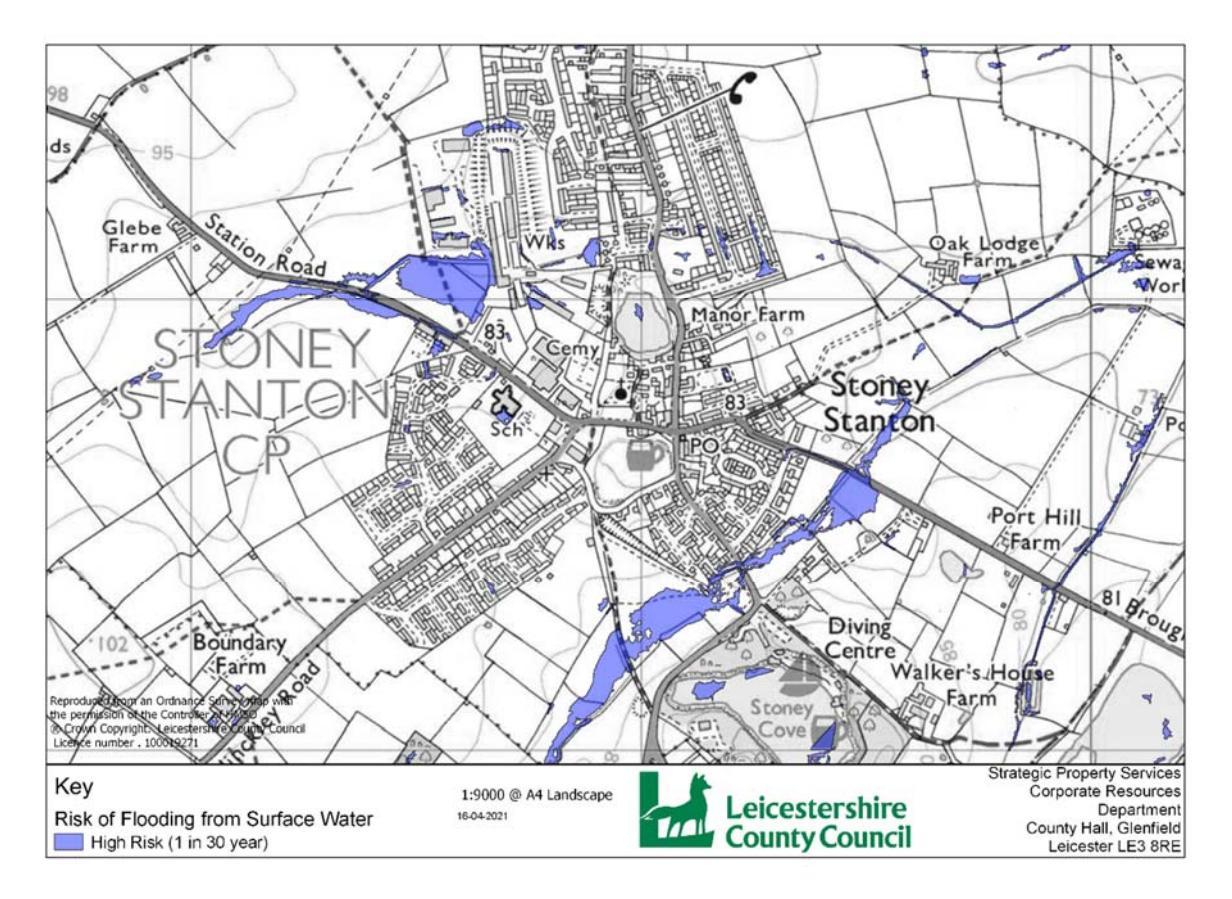
Figure 7: Surface Water Flood Map for Stoney Stanton (purple illustrates the predicted surface water flooding outline for a 1 in 30-year flood event).

The Environment Agency's Surface Water Flood Map, replicated in Figure 7, highlights the extent of the areas at risk high of surface water flooding (in the 1 in 30-year event). The extent of flooding in addition to the locations of affected properties during the event of 1st October 2019 are largely consistent with the high-risk surface water flooding extent.
