# **FLOOD INVESTIGATION REPORT**

Investigation Ref:	54
Location:	Barrs Way, Mountsorrel
Date of Flooding:	1 <sup>st</sup> October 2019

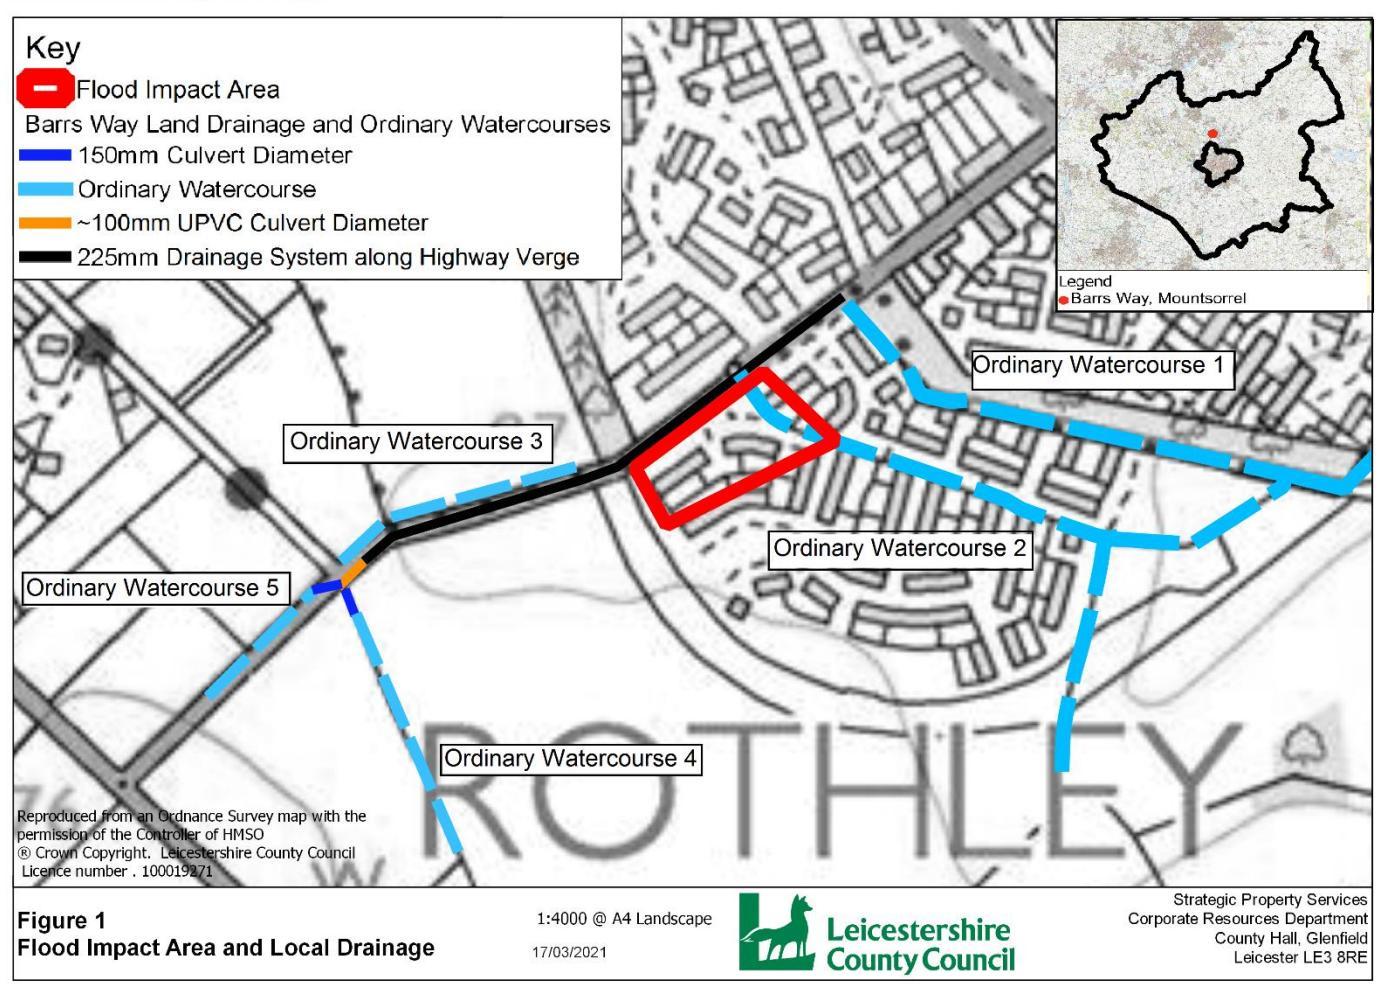
Figure 1 illustrates the locations of key ordinary watercourses within close proximity to the flood impact area. As a result of this investigation, it has been identified that Ordinary Watercourse 2 has been filled in following the development of the Primrose Hill Estate; the impact of this is discussed further in this report. The focus area is approximately 1.3km away from the nearest Main River, Rothley Brook, and the area is categorised as Flood Zone 1 (low risk to fluvial flooding).

This 100mm diameter UPVC culvert connects with the 225mm diameter drainage system shortly downstream (Figure 1). At the time of the flooding incident, it is understood both these systems were heavily silted, with root ingress also found during investigations following the October 2019 flood event within the 225mm diameter drainage system. These restrictions would have likely contributed to the volume of flood water pooling on, and travelling down, West Cross Lane.

The 225mm diameter drainage system flows in an easterly direction along the highway verge before outfalling into Ordinary Watercourse 1 (Figure 1). During the investigation into the drainage system, an obstruction in a section opposite the Carrisbrooke Drive was discovered, which would have occurred during the creation of the access road for the Primrose Hill Estate. This would have likely reduced the capacity of the drainage system to convey flood water during the event. The outfall of this system was also anecdotally reported as being heavily vegetated at the time of the flooding. Although this would not have caused the flooding it may have restricted the ability of the outfall to discharge, which likely increased the volume of flood water on West Cross Lane. Ordinary Watercourse 1 flows through the land of various riparian landowners, including the developer (Persimmon Homes). The Council is working with riparian landowners, including Persimmon Homes, to ensure unrestricted flow within Ordinary Watercourse 1.
